<p>California Public Utilities Commission <i>Mitigation Monitoring, Compliance, and Reporting Program</i></p>
	<p>East County (ECO) Substation Project</p>
	<p>Compliance Status Report: 039</p> <p>September 28, 2014</p>

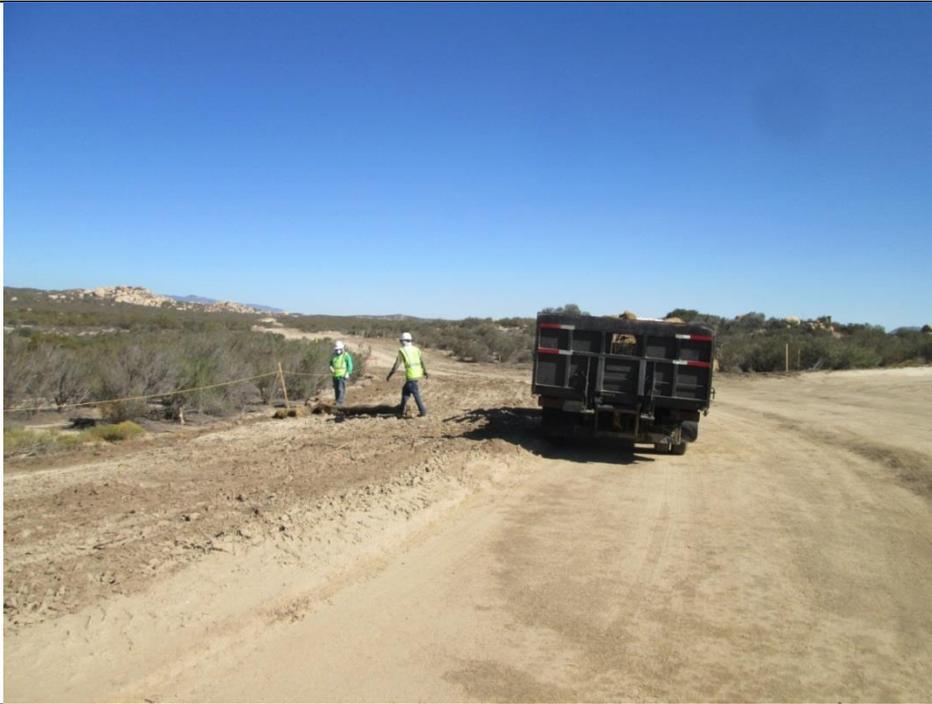
Restoration efforts were observed being completed in accordance with MM-BIO-1d and the associated Habitat Restoration Plan. Crews were observed re-contouring construction areas to pre-construction contours and elevations. Upon completion, crews were observed removing erosion control straw wattles (see Attachment A – Photo 1). The restoration areas will continued to be monitored and measures implemented until success criteria is reached, which includes at least 60 percent of total vegetation cover to be achieved for each plant community, relative to the adjacent reference site with similar vegetation.

Photo 1: In accordance with the Habitat Restoration Plan and MM-BIO-1d, crews were observed removing temporary straw wattles along the restoration areas of underground portion of the right-of-way.

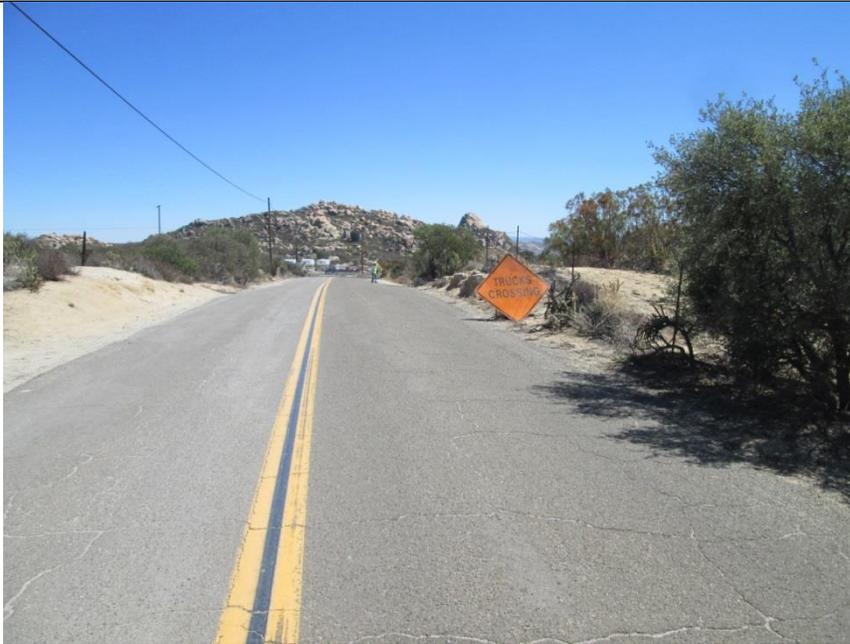
Traffic control measures including informational signs and flaggers were observed in place along Jewel Valley road to support truck hauling activities (gravel base) in accordance with MM-TRA-1 (see Attachment A – Photo 2). Class II base was spread along the Section 1 138 kV Underground Transmission Line ROW during this reporting period.

Photo 2: Traffic control measures consisting of signage and flaggers were observed being implemented along Jewel Valley Road to support trucks hauling Class II road base in accordance with MM-TRA-1.

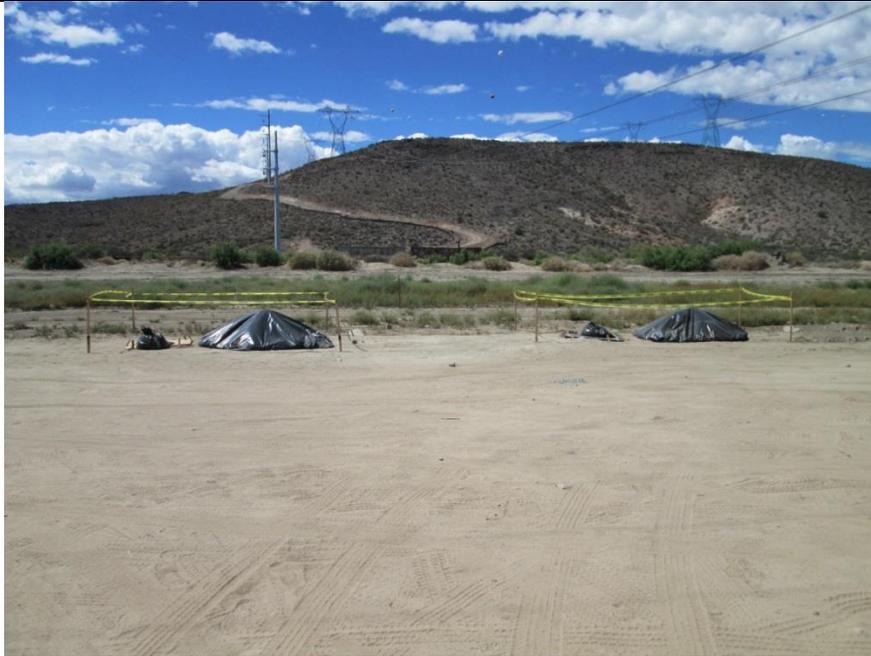
Biological monitors were onsite to ensure construction activities remained within the approved work limits and to monitor for sensitive wildlife species (MM-BIO-1a and MM-BIO-1c). All excavations, such as excavations associated with the 138kV overhead line grounding poles were inspected daily prior to construction activities and throughout the day to ensure that no wildlife species had become entrapped in accordance with MM-BIO-7e (see Attachment A – Photo 3) and spoils from excavations were covered and secured in order to prevent erosion in accordance with the SWPPP and MM-HYD-1.

Photo 3: Holes excavated for steel pole guard structures were observed covered to prevent wildlife entrapment in accordance with MM-BIO-7a and adjacent dirt stock piles were covered and secured to prevent erosion in accordance with the SWPPP and MM-HYD-1.

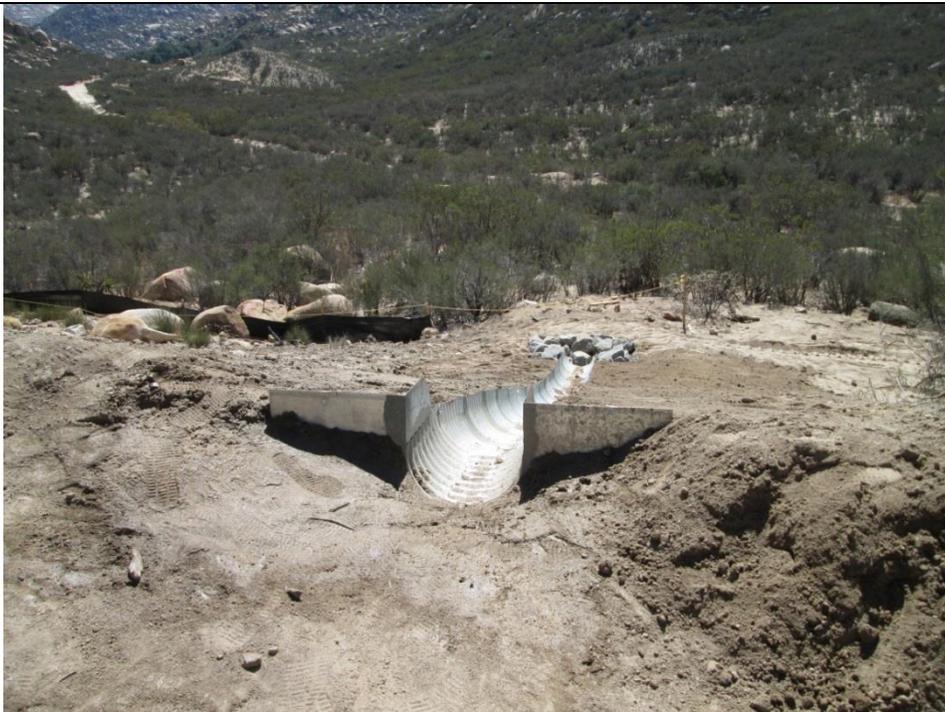
CPUC third party monitors observed activities associated with installing permanent drainage features, such as water dissipating rip-rap, and flumes (see Attachment A—Photo 4). Work limits were clearly delineated and erosion control devices were being maintained in accordance with the SWPPP and MM-HYD-1.

Photo 4: Continued installation of permanent drainage features (flumes) were observed installed along the pad sites associated with the 138kV overhead line in accordance with the SWPPP and MM-HYD-1.

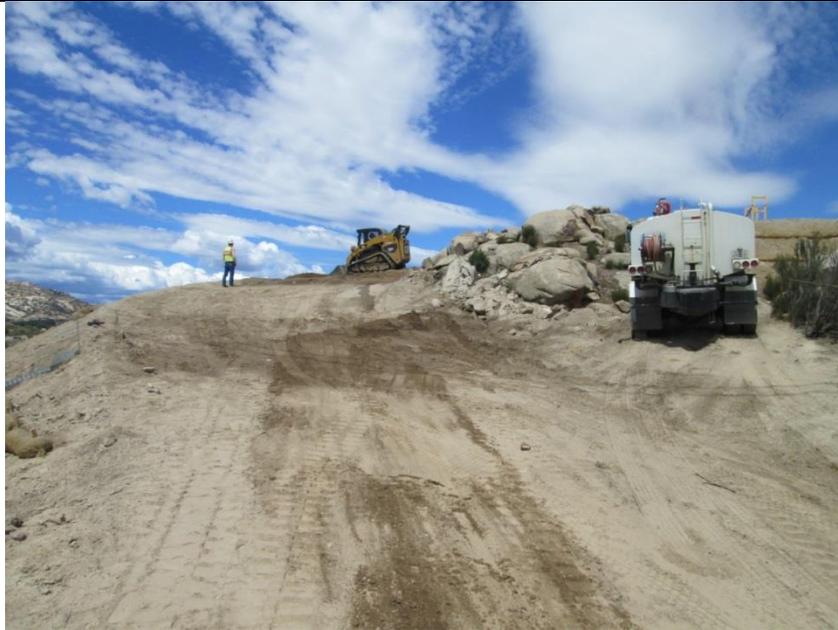
Dust control measures including watering down access roads during final grading activities along the overhead line were observed being implemented in accordance with the Dust Control Plan (MM-AQ-1) and MM-BIO-4a (see Attachment A—Photo 5).

Photo 5: Crews were observed finishing grading activities associated with the access road along the overhead line. Water trucks were observed being utilized to minimize fugitive dust emissions in accordance with MM-AQ-1 and MM-BIO-4a.

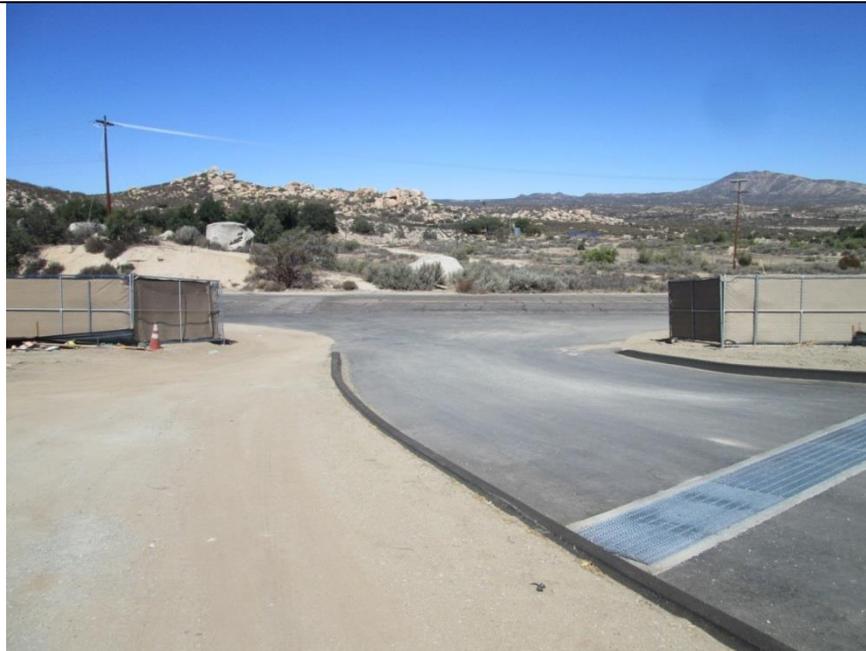
Rattle plates have been installed at the point of ingress/egress to Old Highway were observed in good working condition and sediment track-out was not observed (see Attachment A – Photo 6).

Photo 6: At the Boulevard Substation rebuild site, the point of ingress and egress connecting to Old Highway was observed free of sediment track-out in accordance with the SWPPP and MM-HYD-1. Additionally, in accordance with MM-VIS-3a, the perimeter security fence's screening material was observed being maintained.
